# Survival of Splinted Mini-Implants After Contamination with Stainless Steel

**Purpose:** Dental practitioners are instructed to avoid any type of contact with implant surfaces prior to their insertion. However, the probability of contaminating the surface is high, especially when placement of implants necessitates the use of precise surgical guides. The aim of this study was to evaluate the 2-year survival rate of splinted mini-implants that came into contact with stainless steel prior to their insertion. **Materials and Methods:** During the clinical portion of the study, initiated over a 3-day period, 90 mini-implants were inserted into the anterior mandible of 45 totally edentulous patients; 46 were inserted using a prefabricated stainless steel guide (group 1, bar) and 44 were placed without a guide (group 2, ball). A flapless surgical protocol was used. All implants were immediately loaded with mandibular overdentures, and follow-up was conducted for up to 2 years. The Kaplan-Meier method was used to analyze implant survival in each group, with a confidence level of 95%. In the *in vitro* phase of the study, five mini-implants were contaminated for 20 seconds with a stainle

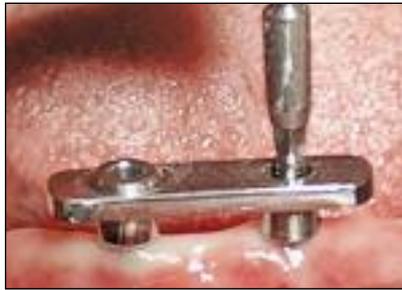
**Fig 1 (left)** Insertion of a mini-implant in contact with the internal surface of a pre-fabricated stainless steel guide.

**Fig 2 (right)** Insertion of a mini-implant without a guide and no metal contamination.

This descriptive study was part of a 2-year randomized trial comparing the bone loss of splinted versus nonsplinted mini-dental implants in edentulous patients (Jofre, unpublished data). Forty-five edentulous people were selected at a public health center in Concepción, Chile. Every participant received oral and written trial information prior to signing an informed consent document to participate. The study protocol was approved by the University's Ethics Committee and the National Commission on Scientific and Technological Research in Chile. During the design of the trial, the research team was unaware that the mini-implant needed to touch the stainless steel surgical guides during insertion. This fact was only analyzed at a later stage, intended to improve the design of the steel guide. It was not the intent of the researchers to knowingly contaminate the implants.

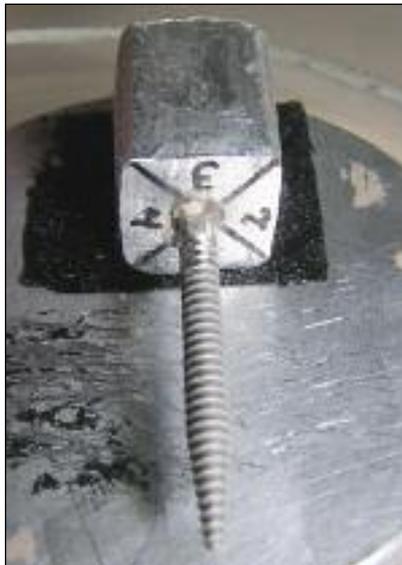
**Fig 3 (left and below)** Mini-implant on a slide for SEM observation and a diagram showing how all four sides of the implant were examined.

360 degrees (Fig 3). The implants were then rotated 90 degrees four times to perform a complete SEM scan; the authors searched for signs of deformation, particulate matter, or contamination.
